SUBJECT: Report on Construction of the Al Kazim Water Supply, Nassriya, Iraq (Report Number SIGIR PA-08-125)

### **SIGIR PA-08-125**

### Al Kazim Water Supply, Nassriya, Iraq

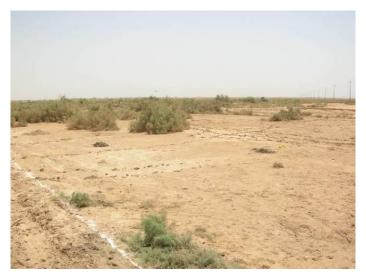
Site Photo 1. Location of the compact unit site (Courtesy of the USACE)

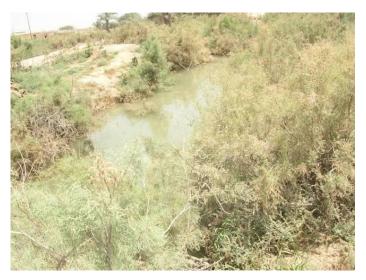
Site Photo 2. Compact unit site's water resource (Courtesy of the USACE)

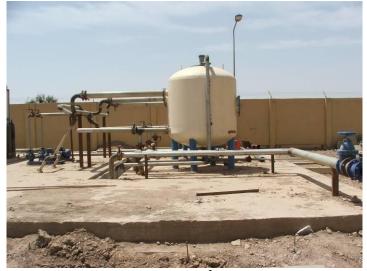
The contractor constructed a new reinforced concrete pad for the 50-m<sup>3</sup>/hr compact unit water treatment plant (Site Photo 5). The structural concrete SIGIR observed did not have any noticeable cracking, segregation, or honeycombing areas.

Site Photo 5. Reinforced concrete pad for 50-m<sup>3</sup>/hr compact unit water treatment plant

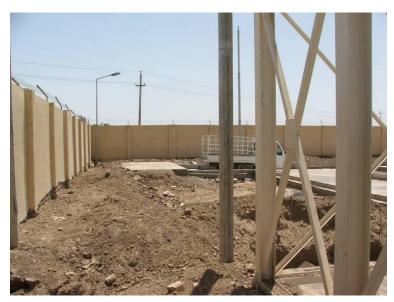
SIGIR observed significant work underway in the Al Kazim Water Supply construction area. For example, for the security of the plant and its operators, the description of work required exterior site fencing consisting of brick and topped with three strands of barbed wire. At the time of our second site visit, SIGIR observed that the exterior site fencing was nearly completed, including the three strands of barbed wire and perimeter lighting (Site Photo 6).

Site Photo 6. Site fencing with barbed wire and perimeter lighting

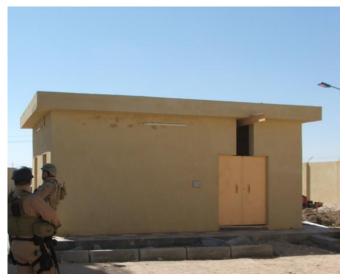
At the time of our second site visit, the contractor had not completed the chemical building, operator building, and water compact unit. For example, electrical work was still required in both the chemical and operator buildings (Site Photo 11). In addition, the contractor had not installed the crane for the chemical building (Site Photo 12). Further, the water compact unit sunshade and the generator and fuel tank sunshade were not constructed.

Site Photo 12. Chemical building's crane in progress

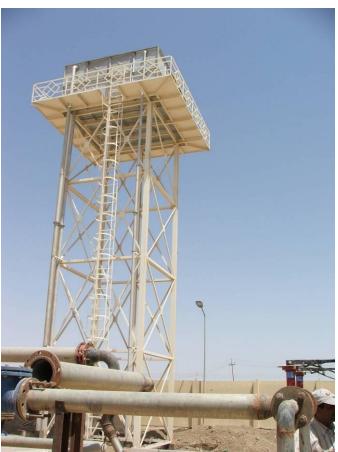
The contractor did finish construction of a new elevated storage reservoir (Site Photo 13).

Site Photo 13. Elevated storage tank

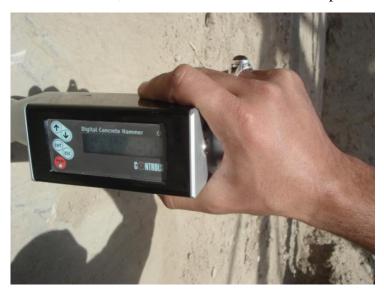
During the site visit, the GRS representative stated that the elevated storage tank's concrete foundation had not passed the Hammer (Site Photo 14) and Ultrasonic (Site Photo 15) tests. The elevated storage tank's concrete foundation would not support

Site Photo 14. Hammer test for elevated storage tank (Courtesy of the USACE)

the full load of the elevated storage tank when filled completely with water. The contractor provided the GRS a corrective action proposal plan for the concrete foundation. The corrective action plan for the elevated storage tank states that if the concrete foundation fails the core test and the second ultrasonic test, then the steel structure will be taken down, and a new concrete foundation will be constructed. In a follow-up email, the GRS stated that the concrete foundation failed the core test. The contractor would remove the elevated storage tank, and the contractor would use the old foundation as a blind, and the new foundation will be poured on top.

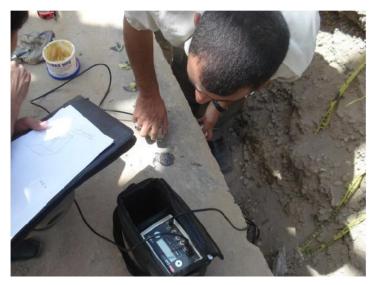
Site Photo 15. Ultrasonic test for elevated storage tank (Courtesy of the USACE)

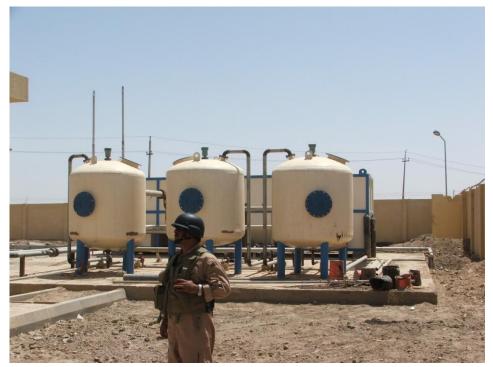
Since the Al Kazim Water Supply project was reported as 55% complete at the time of SIGIR's second site visit, there was significant interior and exterior work remaining on the water compact unit. The other required pending work included civil and site works, an internal road network and perimeter security roads, potable water treatment and distribution systems, a power generation system, sunshades (Site

Site Photo 16. Water compact unit without sunshade.
